Request for Qualifications, 17MCO519 DESIGN - BUILD SERVICES

**CRTC Building
215 W. Industrial
Midland, Texas**

February 13, 2014
Terracon Project No. 94147043

Prepared by:
Terracon Consultants, Inc.
Dallas, Texas

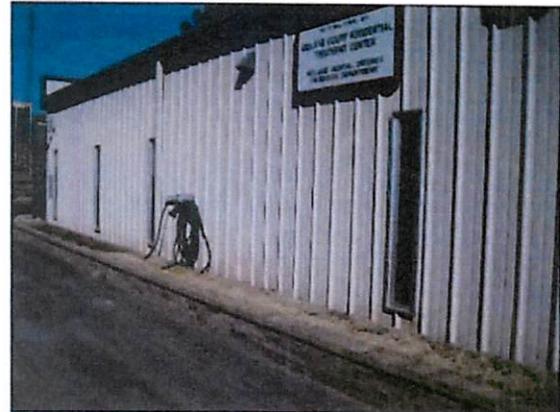
Exterior Metal Walls (Photos 1-21): The building exterior envelope exhibited visual evidence of chronic water exposure at various locations. Moderate to significant rust/metal deterioration was observed at the base of the vertical metal panels, primarily in the general vicinity of the north and south wing restrooms. The southwest exterior metal panels, common with the south wing restroom, the northwest exterior metal panels, common with the north wing west restroom, the Recreation Yard exterior metal panels, common with the north wing east restroom and the southeast exterior metal panels common with the laundry room exhibited the referenced rust/metal deterioration. Mr. Davenport reported that during deconstruction of the north wing east restroom it was discovered that there was not a shower pan installed in the shower. The absence of a shower pan in the north wing east restroom is consistent with the rust/metal deterioration observed on the metal exterior panels common with this location. The rust/metal deterioration of the exterior metal panels common with the north wing west restroom and south wing restroom suggests the showers in these locations are constructed in a similar manner. The minor rust/deterioration on the southeast exterior common with the laundry appeared to be related to historical plumbing leaks.

Photo 3 West exterior, rust/deterioration in vicinity of south wing restroom

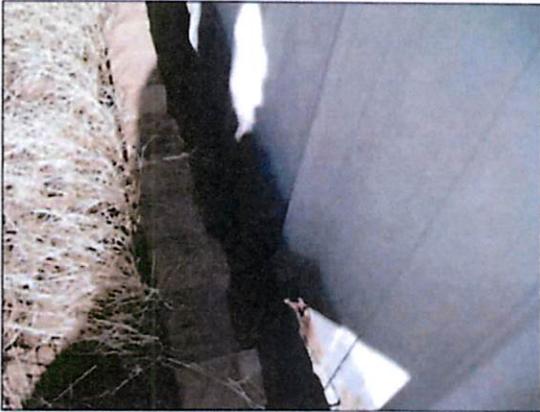
Photo 6 West exterior, north wing, rust/deterioration at faucet head

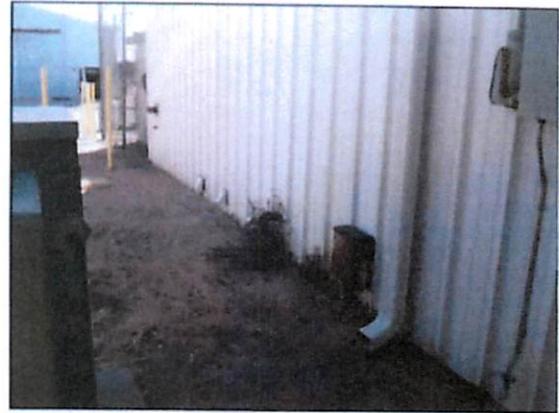
Photo 7 West exterior, north wing, rust/deterioration in vicinity of north wing west restroom

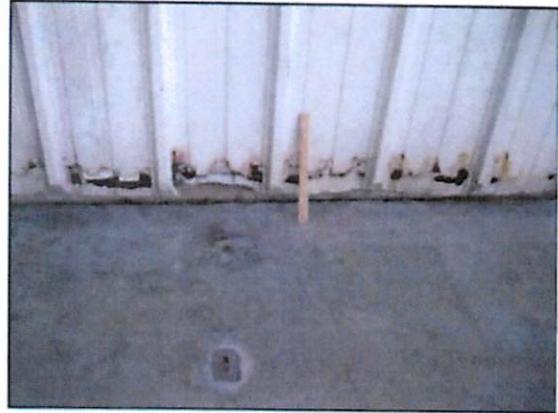
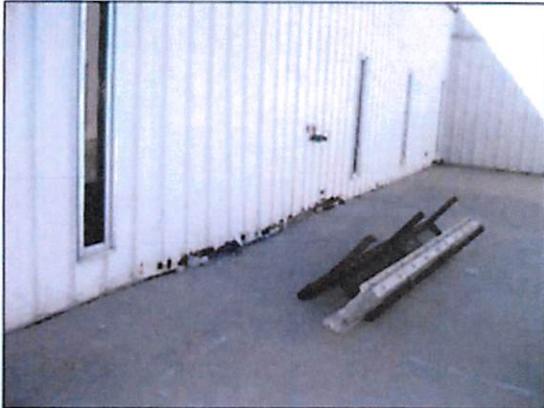
Additionally, rust/metal deterioration was observed in the Recreation Yard in the southwest, northwest, northeast and southeast corners. The rust/metal deterioration at the referenced locations did not appear to be associated with water sources related to restrooms or known areas where plumbing lines would be anticipated to be present. The Recreation Yard concrete surface appeared to be adequately sloped to two drains located in the Recreation Yard suggesting that standing surface water would not accumulate at the southwest, northwest, northeast and southeast corners. Based on the observed exterior rust/metal deterioration, the source of the water intrusion at the referenced locations appeared to be related to potential leaks in the metal roof or roof flashing and subsequent moisture migration through the exterior wall systems.

Photo 13 Recreation Yard, rust/deterioration on metal exterior, southwest corner common with Room 1

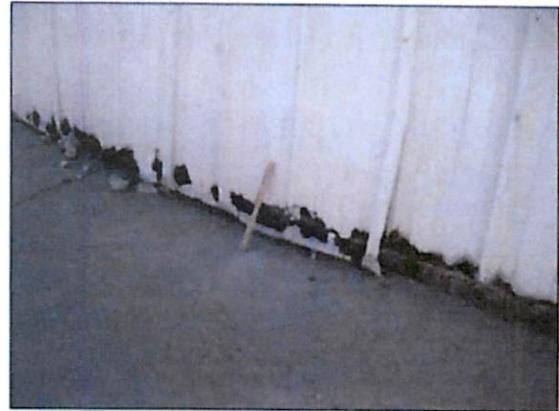
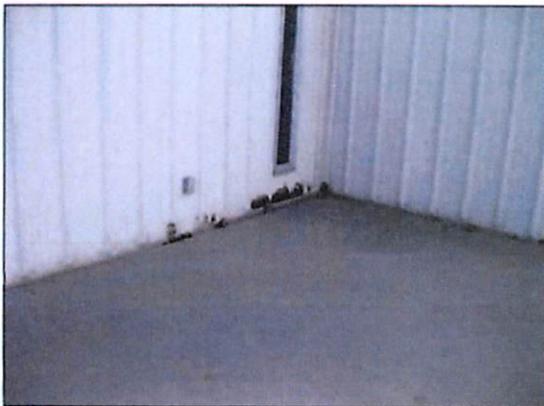
Photo 15 Recreation Yard, rust/deterioration on metal exterior in vicinity of north wing

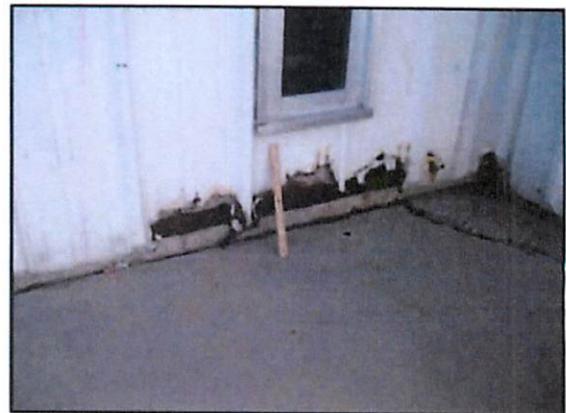
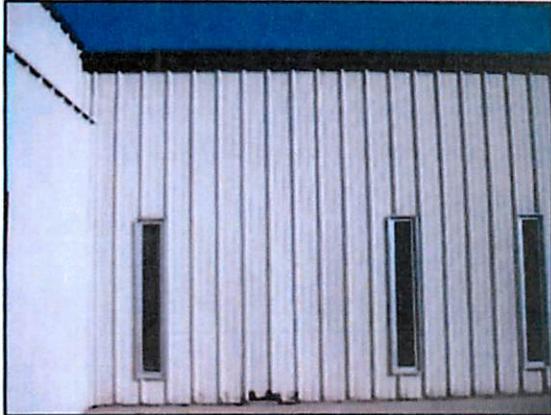
Photo 17 Recreation Yard, rust/deterioration on metal exterior, northwest corner, common with Room 7

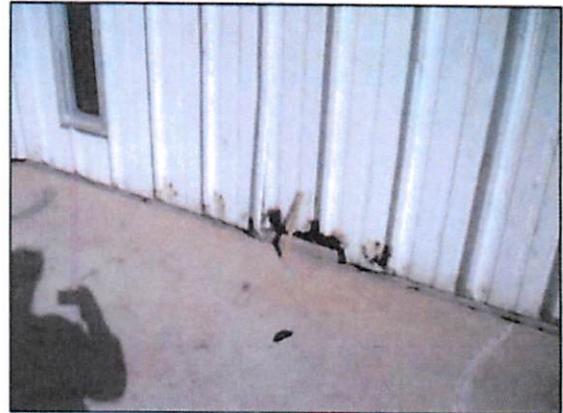
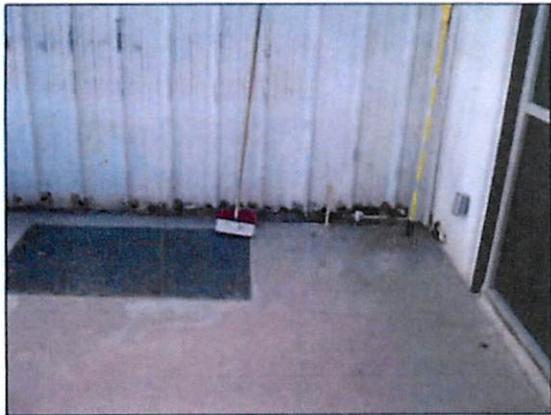
Photo 19 Recreation Yard, rust/deterioration on metal exterior, northeast corner, common with Admin Office 3

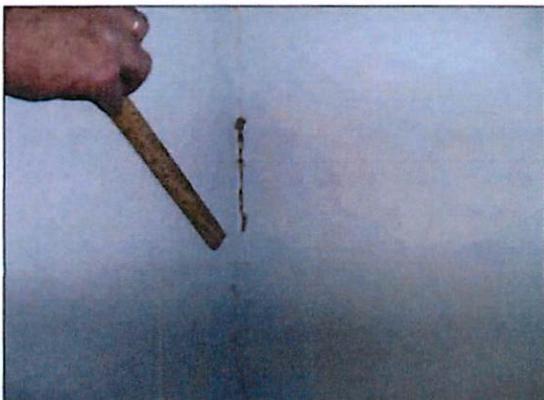
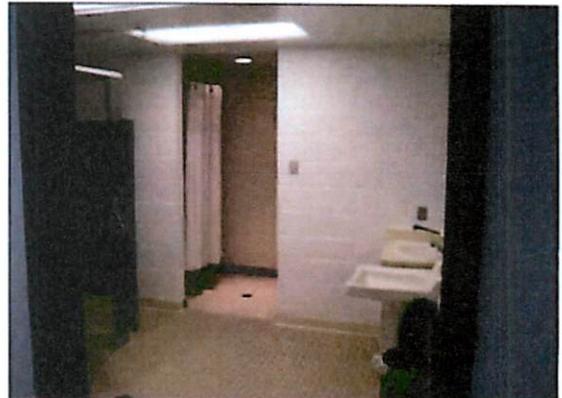
South Wing, Room 4 (Photos 27-29): Room 4 was located adjacent the south wing restroom. Visible evidence of a previous wall repair was observed at the southwest corner wall, common with the restroom. A crack was also evident in the southwest corner of the patched wall. Moisture content of the wall system was normal at the time of the IEQ evaluation as indicated by IR thermography and confirmed with a hand held digital moisture meter.

Photo 28 South wing, Room 4, southwest corner common with south wing restroom, evidence of previous wall repair/patch

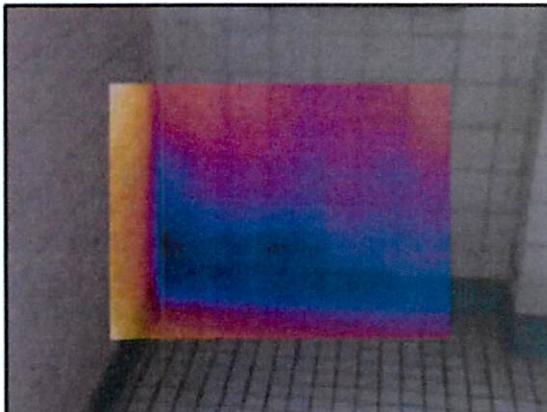
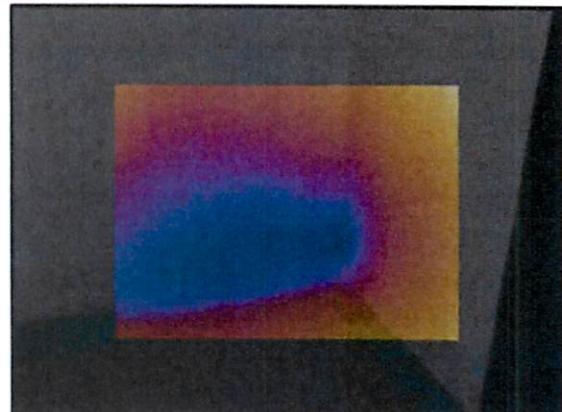
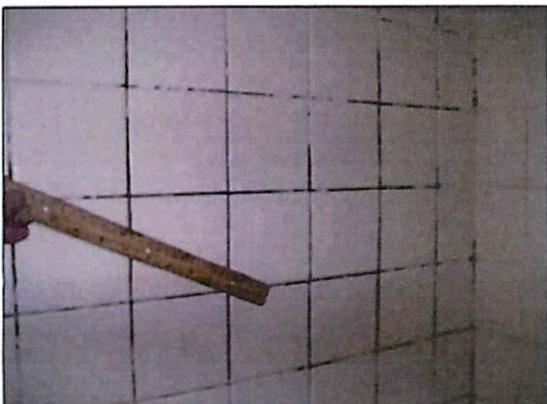
South Wing Restroom (Photos 30-36): The shower area of the restroom, common with Room 4, exhibited residual moisture on the lower section of the wall within the ceramic tile substrate as indicated by IR thermography (Photos 32-34). Additionally, typical fungal growth was observed on the ceramic tile grout of the shower. There was not an exhaust fan/ventilation installed in the restroom at the time of the IEQ evaluation.

Photo 32 South wing restroom, shower area, evidence of residual moisture in wall system as viewed through IR camera

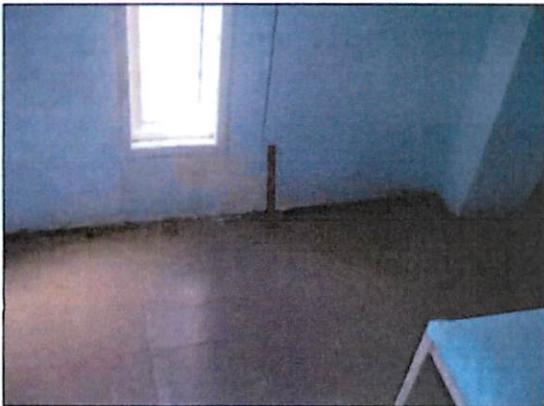
North Wing, Room 4 (Photos 39, 40): Visible evidence of previous wall repair was observed adjacent the window on the exterior west wall (Photos 39, 40). Moisture content of the wall system was normal at the time of the IEQ evaluation as indicated by IR thermography and confirmed with a hand held digital moisture meter.

Photo 40 North wing, Room 4, evidence of previous wall repair/patch on exterior wall system

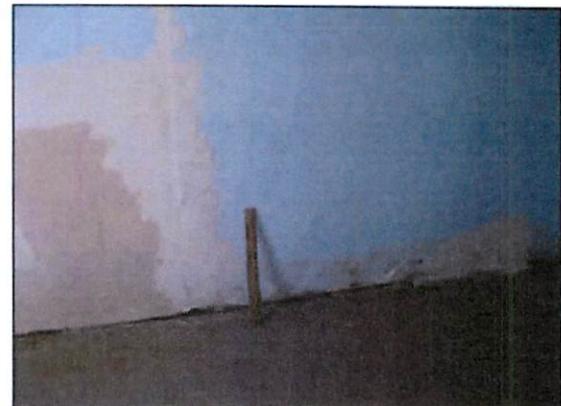
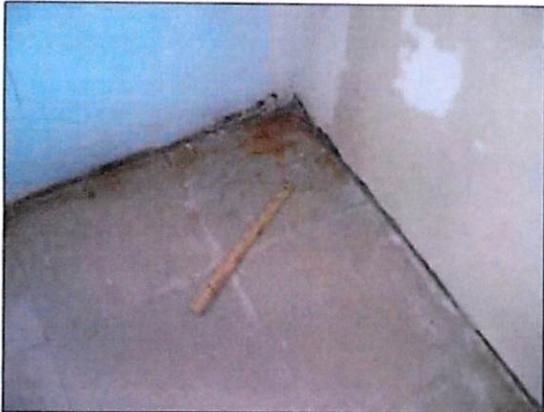
North Wing, Room 6 (Photos 41-43): Room 6 was located adjacent the north wing west restroom. Visible evidence of a previous wall repair was observed adjacent the window on the exterior west wall (Photos 41). Additionally, visible evidence of previous wall repairs was observed at the wall common with the north wing west restroom (Photos 42). Apparent rust stains were present on the floor tile adjacent the repair location common with the north wing west restroom, suggesting historical moisture migration through the wall system (Photo 43). Moisture content of the wall system was normal at the time of the IEQ evaluation as indicated by IR thermography and confirmed with a hand held digital moisture meter.

Photo 41 North wing, Room 6, evidence of previous wall repair/patch on exterior wall system

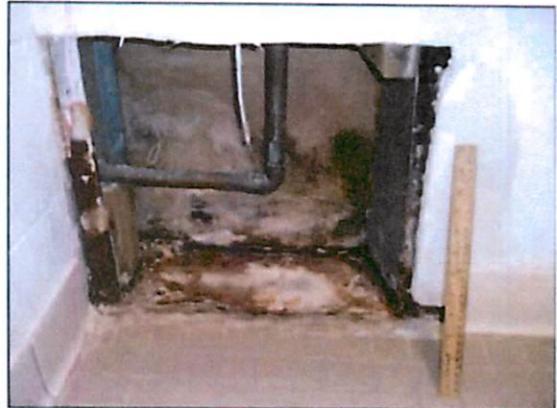
North Wing, West Restroom (Photos 44-51): Mr. Davenport previously reported that a building occupant created a hole in the north wall adjacent the shower enclosure. Visible fungal growth was observed within the exposed interstitial wall cavity on the wall cavity side of the gypsum wallboard in Room 8, common with the west restroom (Photos 45, 46). The shower enclosure exhibited residual moisture on the lower section of the wall within the ceramic tile substrate as indicated by IR thermography (Photos 49, 50). An exhaust vent was installed in the ceiling of the west restroom and was ducted to the exterior west wall (Photos 51 and 68, 69).

Photo 45 North wing, west restroom, west wall previously deconstructed

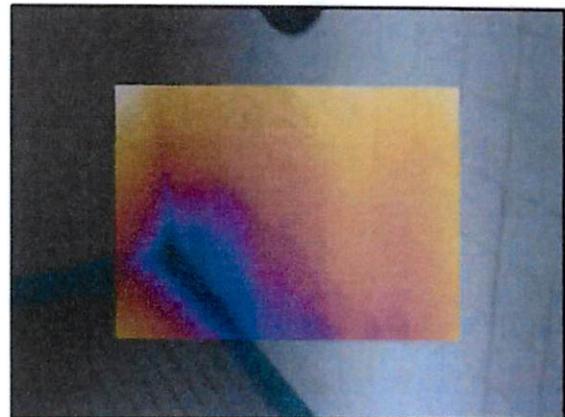
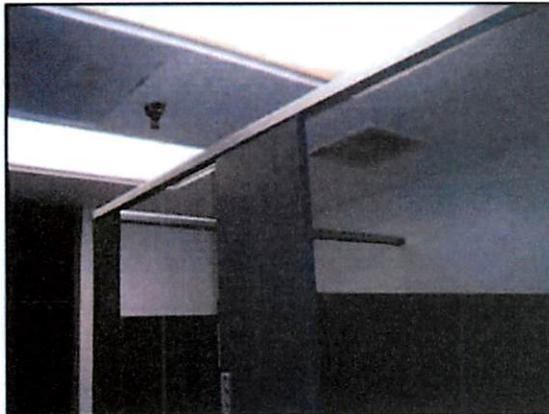
Photo 49 North wing, west restroom shower area, evidence of residual moisture in wall system as viewed by IR camera

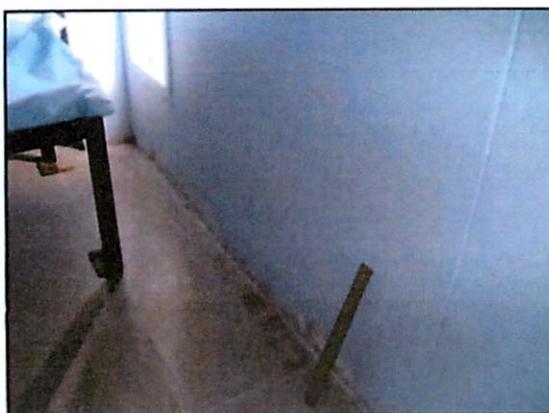
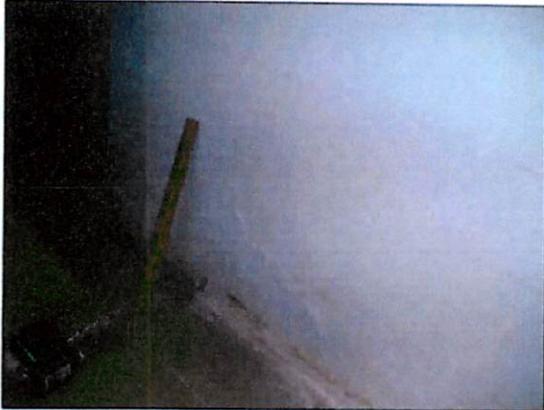
North Wing, Room 8 (Photos 52-57): Room 8 was located adjacent the north wing west restroom. Rust was evident on the floor tile adjacent the west exterior wall, suggesting historical moisture intrusion through the exterior wall or from the adjacent north wing west restroom (Photo 53). Evidence of previous wall repairs and paint delamination were evident at the southwest corner, common with the north wing west restroom (Photos 54, 55). Elevated moisture was detected where paint delamination was observed on the south wall common with the north wing west restroom by IR thermography (Photos 56, 57). The moisture content was measured at 22 % with a hand held digital moisture meter. There was no visible fungal growth at the time of the IEQ evaluation.

Photo 52 North wing, Room 8, wall common with west restroom, evidence of previous repair/patch

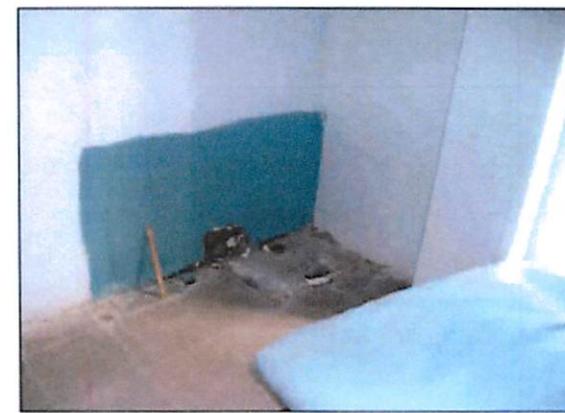
Photo 53 North wing, Room 8, exterior wall, rust on floor tile adjacent wall

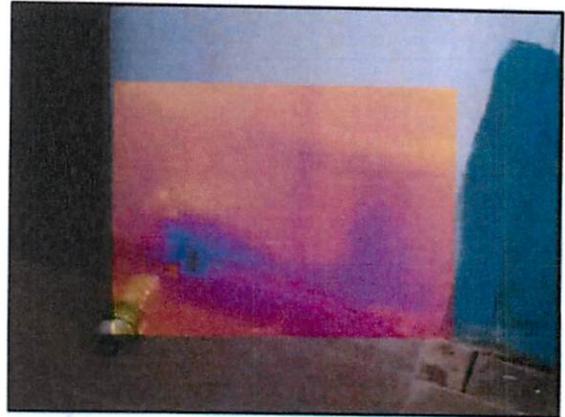
Photo 55 North wing, Room 8, wall common with west restroom, delaminating paint, elevated moisture

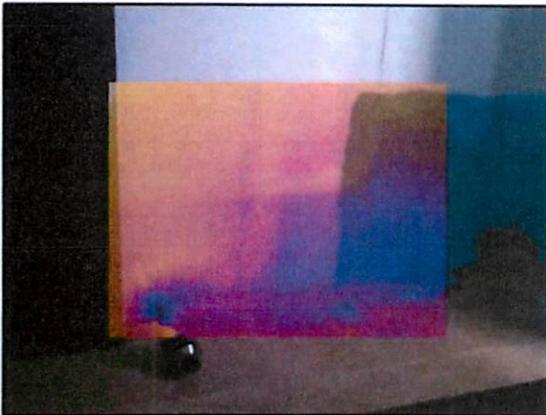
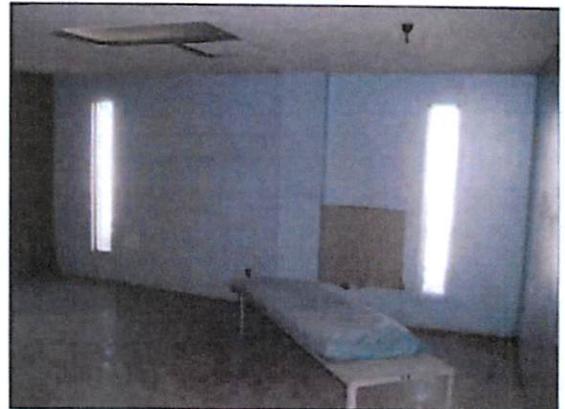
Photo 56 North wing Room 8, wall system common with west restroom evidence of moisture as viewed through IR camera

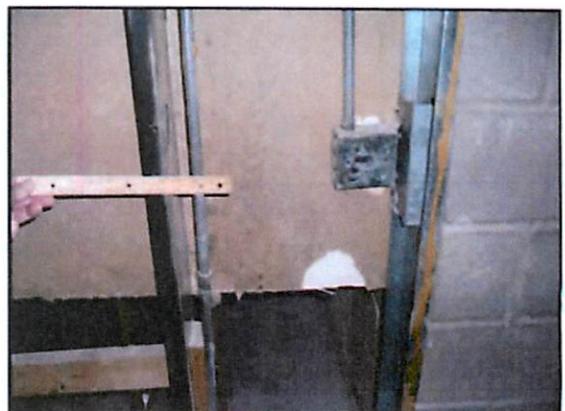
site reconnaissance, a section of the north wall common with the east restroom had been removed from floor to ceiling level, exposing the concrete masonry unit (CMU) shower enclosure and the metal framing (Photo 59). Minor fungal growth was observed on the exposed gypsum wallboard and the metal framing exhibited severe rust/deterioration suggesting long term exposure to moisture (Photos 60, 61). The quantity of visible fungal growth was estimated at two (2) square feet.

Photo 59 North wing Room 3, wall system common with east restroom, previously deconstructed

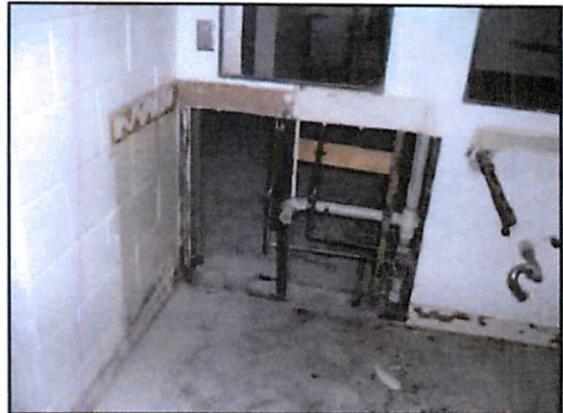
North Wing, East Restroom (Photos 62-66): The ceramic tile on the walls and floor of the shower enclosure had been removed prior to the site reconnaissance (Photo 63). Mr. Davenport previously indicated that during the deconstruction of the shower it was discovered that there was not a shower pan installed in the floor of the shower. Additionally, sections of the gypsum wallboard had been deconstructed exposing water damage and rust/deterioration on the metal framing consistent with long term moisture exposure (Photos 64). Minor fungal growth was observed on the exposed south wall behind floor trim which had previously been removed (Photo 65). The quantity of visible fungal growth behind the floor trim was estimated at less than one (1) square foot.

Photo 63 North wing, east restroom, west wall previously deconstructed

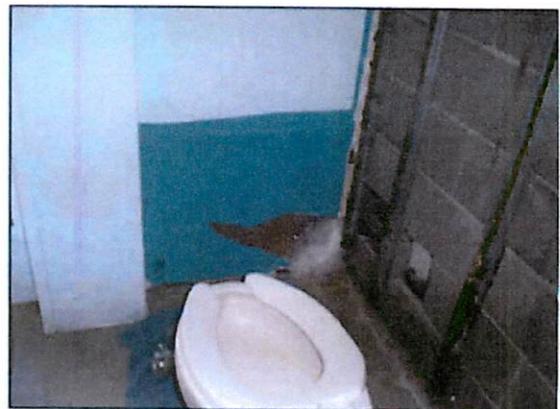
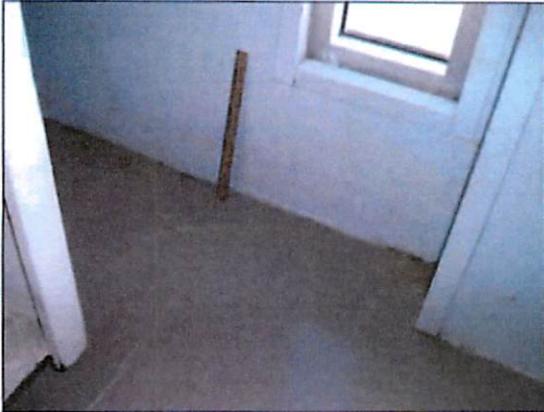
North Wing, Room 5 (Photos 70-73): Room 5 was located adjacent the north wing east restroom. A section of the wall, common with the east restroom, had previously been removed from floor to ceiling level, exposing the CMU shower enclosure and the metal framing (Photo 71). The metal framing exhibited rust/deterioration consistent with long term moisture exposure (Photo 72). Apparent rust stains were also observed on the floor tile adjacent the window, suggesting historical moisture migration through the east exterior wall system or from the adjacent shower enclosure (Photos 73).

Photo 71 North wing, Room 5, wall common with east restroom, wall system previously deconstructed

Photo 72 North wing, Room 5, wall common with east restroom, wall system previously deconstructed, rust/deterioration on metal wall studs

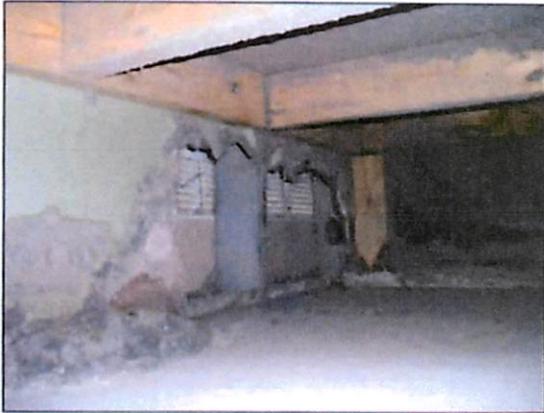
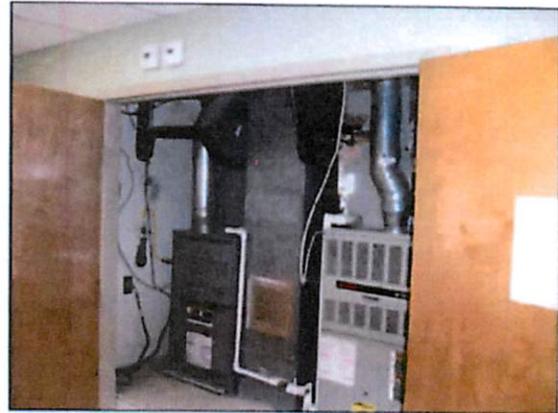
Air Handling Units (Photos 74-83): The indoor environment was provided conditioned air by several vertical AHU's located in mechanical closets at different locations within the facility. The interior components of the AHU's were not accessible for visual evaluation.

Photo 78 North wing vertical AHU, return air plenum, evidence of water staining, suspect fungal growth

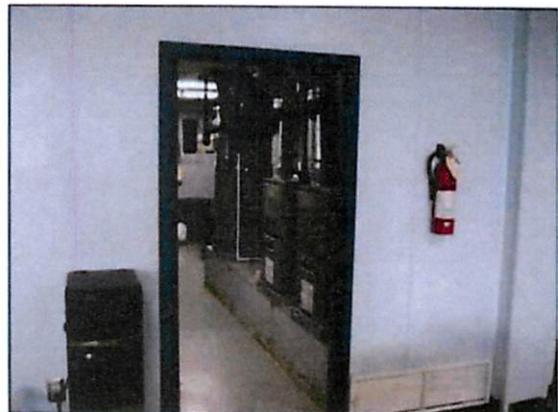
Photo 81 Administration wing, vertical AHU platform, evidence of water damage
