**Request for Qualifications, 19MCO543**  
**In response refer to RFQ No. 19MCO543 Addendum 1 (one) with Questions and Answers**  
**February 7, 2019**

**Two-Story Office Building  
509 North Loraine Street  
Midland, Texas**

July 29, 2017  
Terracon Project No. AR177124

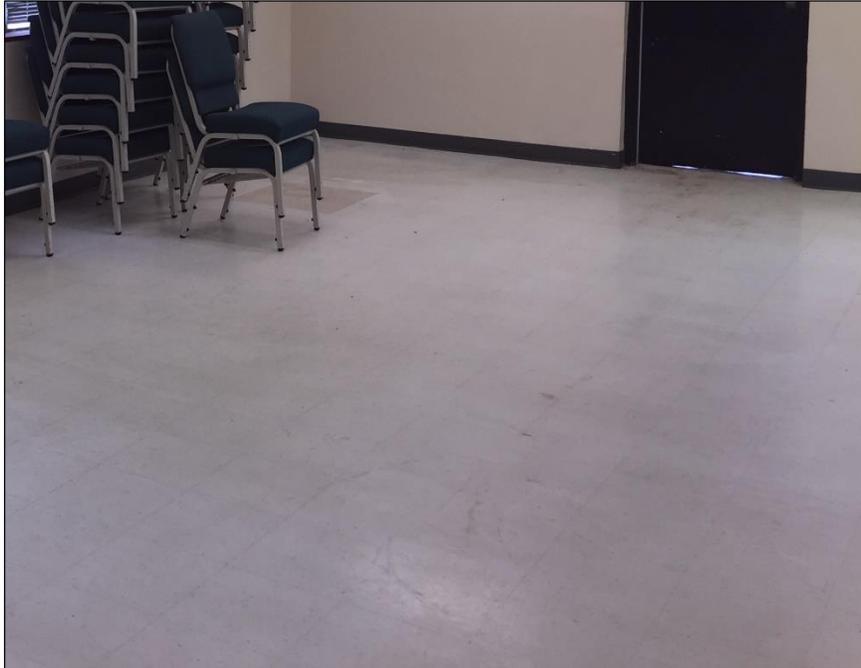
**Photo 3.** View of the 12"x12" vinyl floor tile (gray, mottled) with ACM black mastic.

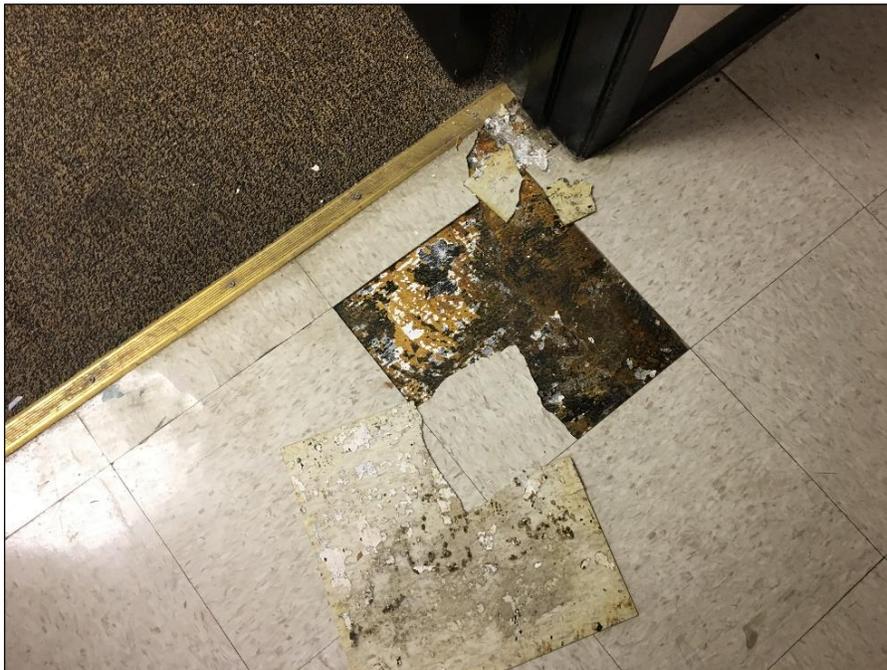
**Photo 4.** View of the 12"x12" vinyl floor tile (tan, mottled) and ACM black mastic

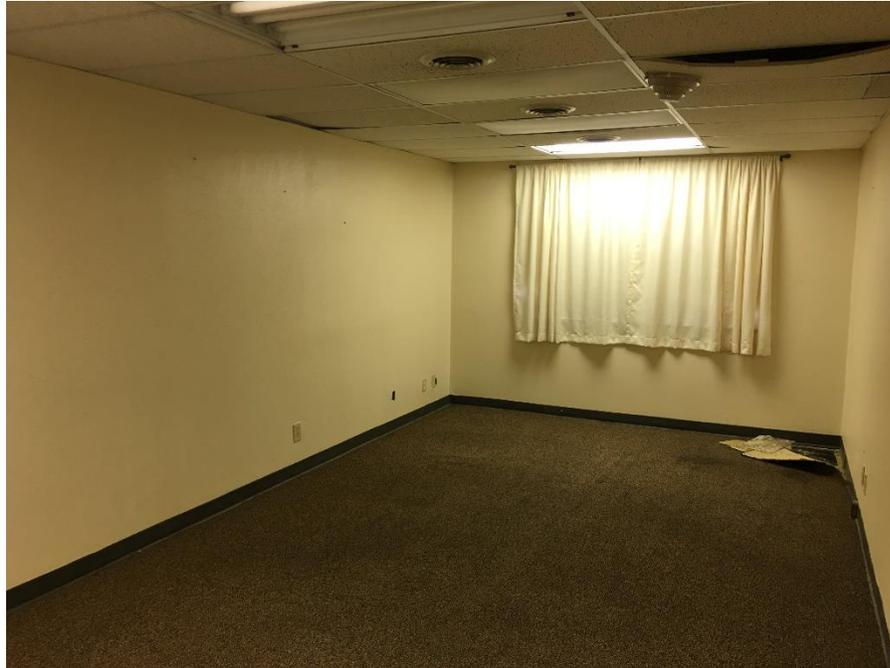
Terracon inspected several areas under the carpeting and floor tile in the subject building and did not observe additional floor coverings/layers except where noted in this report. However, the potential exists for additional flooring to be present beneath the carpet and floor tile. If flooring is encountered beneath the carpet or floor tile that has not been tested the material should be assumed to be asbestos containing until the material is tested and confirmed non-ACM.

**Photo 5.** View of the carpet over ACM 12"x12" vinyl floor tile and black mastic in the first floor offices.

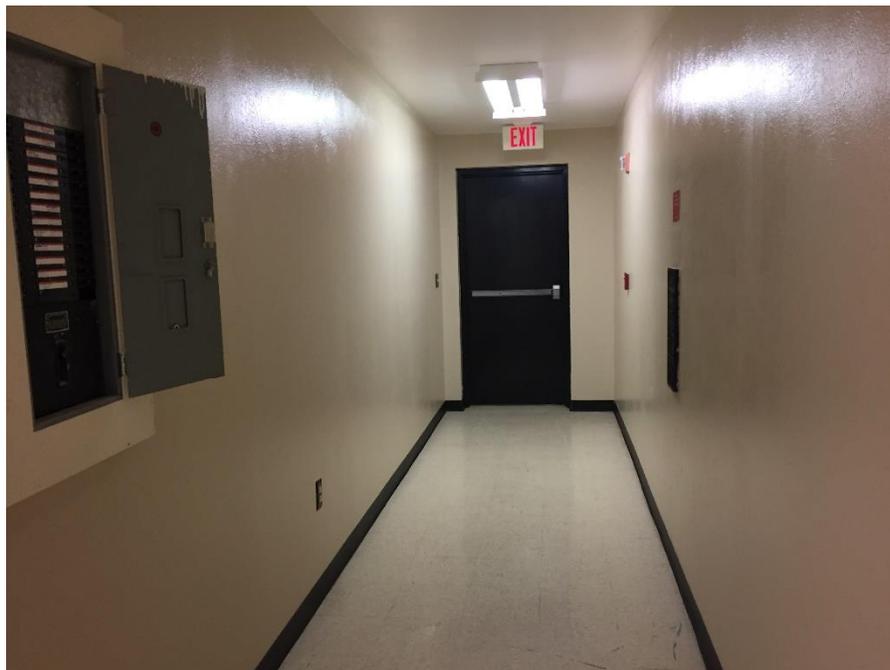
**Photo 6.** View of drywall wall system with ACM texture and joint compound.

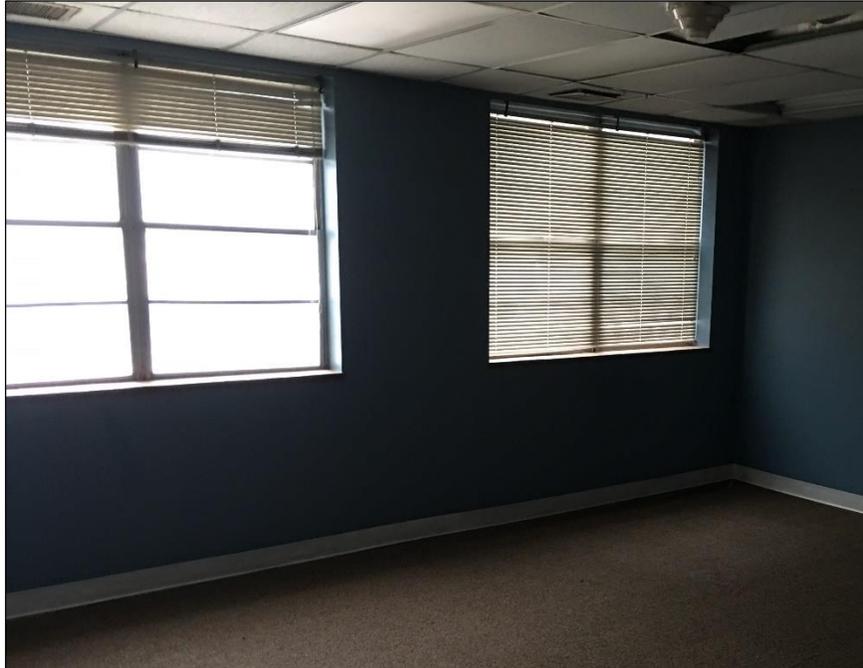
Two (2) of five (5) samples collected from the friable wall plaster/wallpaper wall system observed on the perimeter walls of the 1<sup>st</sup> and 2<sup>nd</sup> floors were determined to contain 2% Chrysotile asbestos by PLM visual estimation. Based on the initial analysis, these samples (#41 and #42) were resubmitted for point count analysis by PLM and Sample #41 was confirmed to contain 1.75% Chrysotile asbestos. Therefore, based on the point count analysis this material meets the regulatory definition of asbestos containing materials by TAHPR. As field observations indicate this plaster/wallpaper wall system is homogeneous throughout building, Terracon must classify this material is asbestos containing where present.

**Photo 7.** View of the friable wall plaster/wallpaper wall system wall with ACM joint compound.

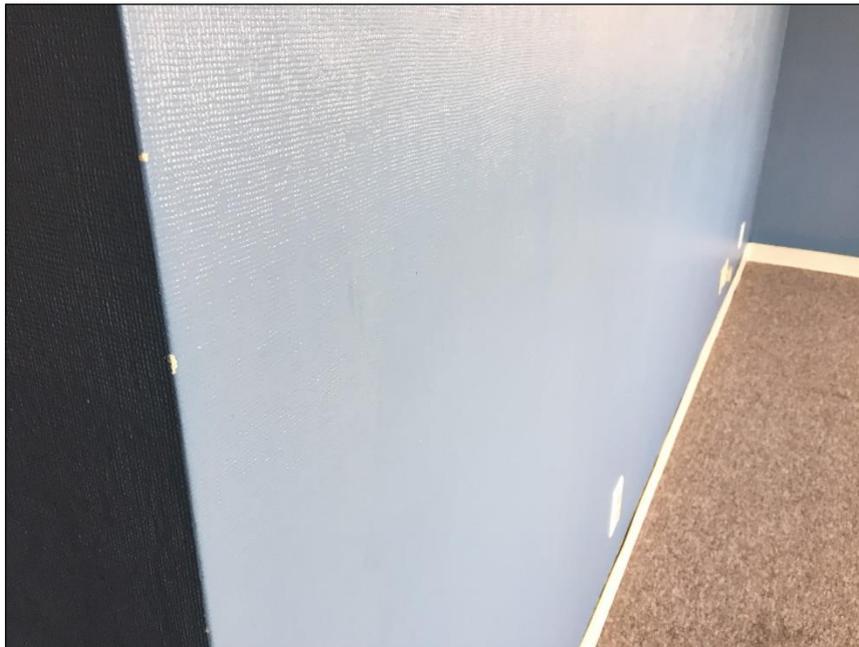
**Photo 8.** View of the drywall/joint compound/tape/wallpaper wall system with ACM joint compound on the accent walls.

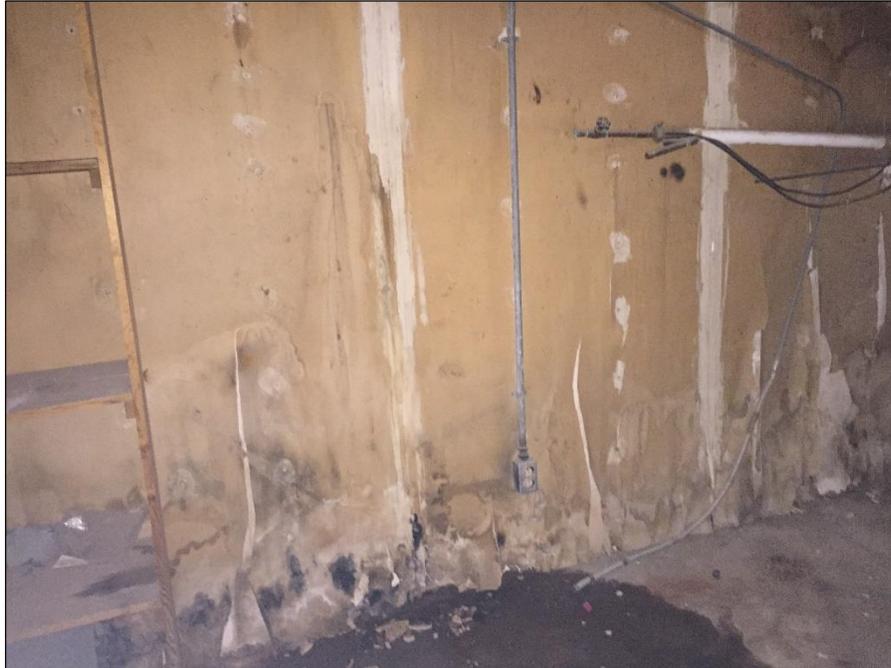
**Photo 9.** View of drywall/joint compound wall system with ACM joint compound.

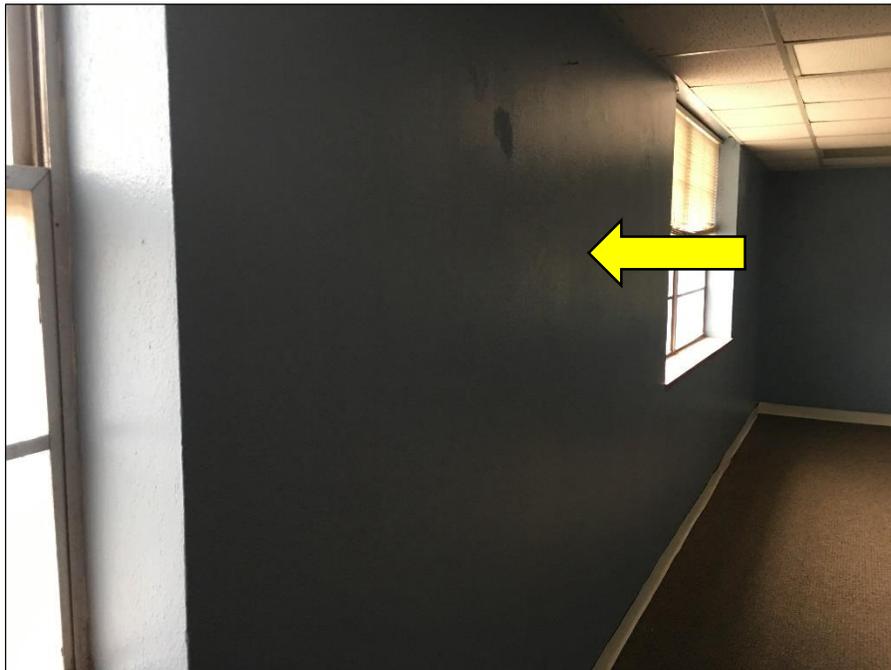
The asbestos-containing wall plaster (two types) observed on the perimeter walls was assessed to be in good condition but friable on the day of the survey. The remaining ACMs were assessed to be nonfriable and in good condition. Terracon understands that the subject building is scheduled for renovation. Therefore, the identified ACMs must be abated prior to renovation operations that would disturb this material.

**Photo 10.** View of the friable wall plaster/texture wall system wall with ACM joint compound.

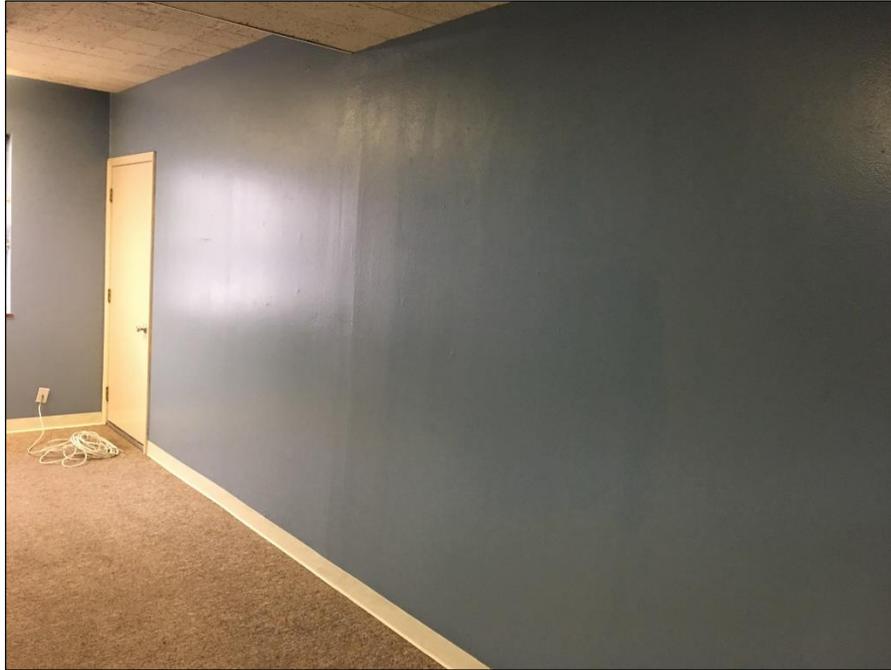
**Photo 11.** View of drywall/joint compound/tape/texture wall system (teal, smooth) with ACM texture and joint compound.

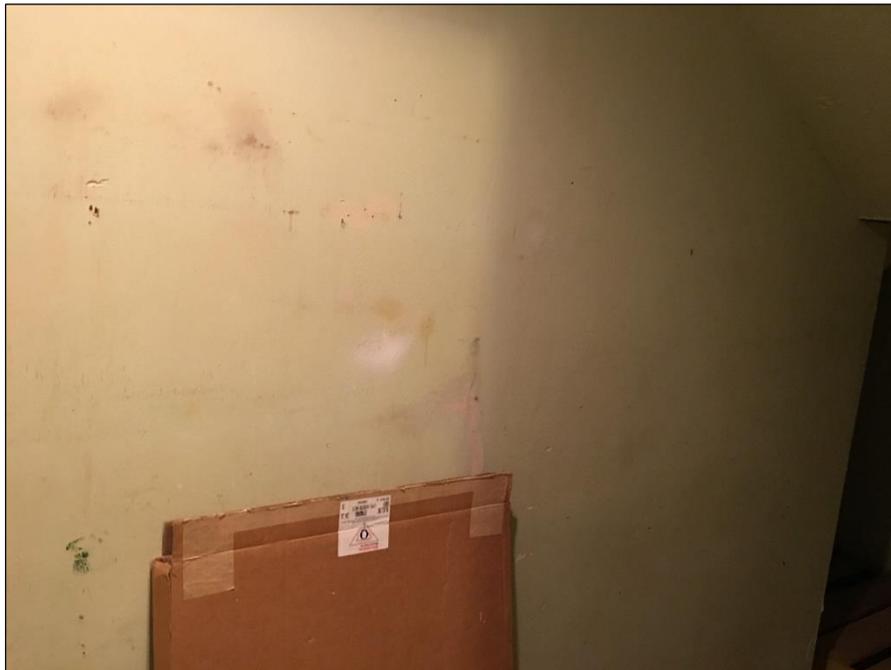
**Photo 12.** View of drywall/joint compound/tape/texture wall system (beige, rough) with ACM texture and joint compound under stairs.

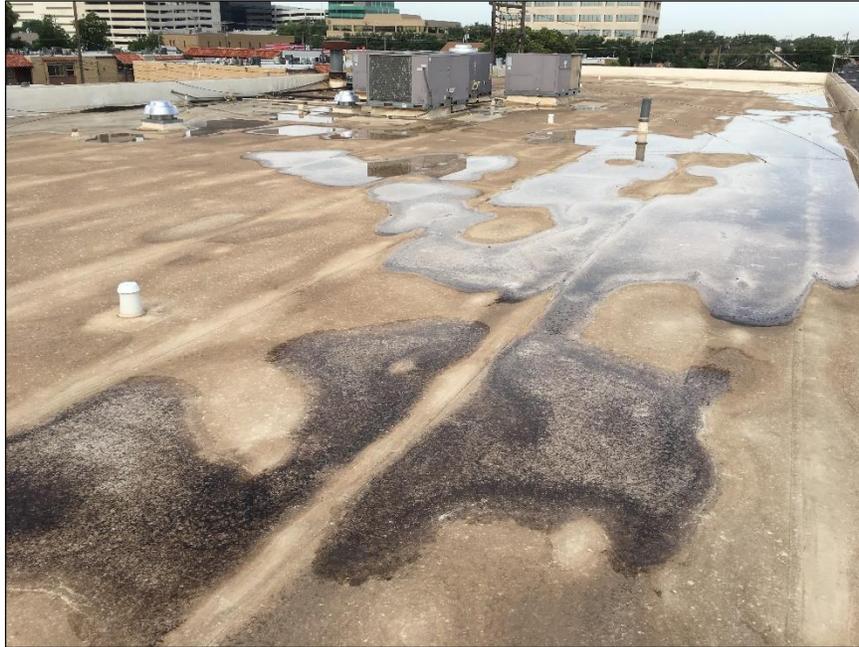
Asbestos was identified in the roof tar captured in core samples collected from beneath the membrane roofing. Because the membrane roof prevented observation of the roof field beneath, Terracon must assume the ACM tar is present in all areas where the roof membrane is in place. Terracon estimates approximately 6,650 total square feet of built-up roofing material with nonfriable ACM roof tar are present beneath the membrane. It is EPA's interpretation that when a rotary blade (RB) roof cutter or equipment that similarly damages the roofing material is used to remove Category I nonfriable asbestos-containing roofing material, any project that impacts 5,580 square feet or greater of ACM is subject to the NESHAP and would require the material be removed and disposed of as ACM. Conversely, when an RB roof cutter or equipment that similarly damages the roofing material is used to remove Category I nonfriable asbestos-containing roofing material in a roof removal project that impacts less than 5,580 square feet of ACM, the project is not subject to the NESHAP, except that notification is always required for demolition projects. EPA further construes the NESHAP to mean that if slicing or other methods that do not sand, grind, cut or abrade Category I nonfriable ACM will be used, the NESHAP does not apply, regardless of the area of roof to be removed.

**Photo 13.** View of membrane roof over built-up roof with ACM roof tar.

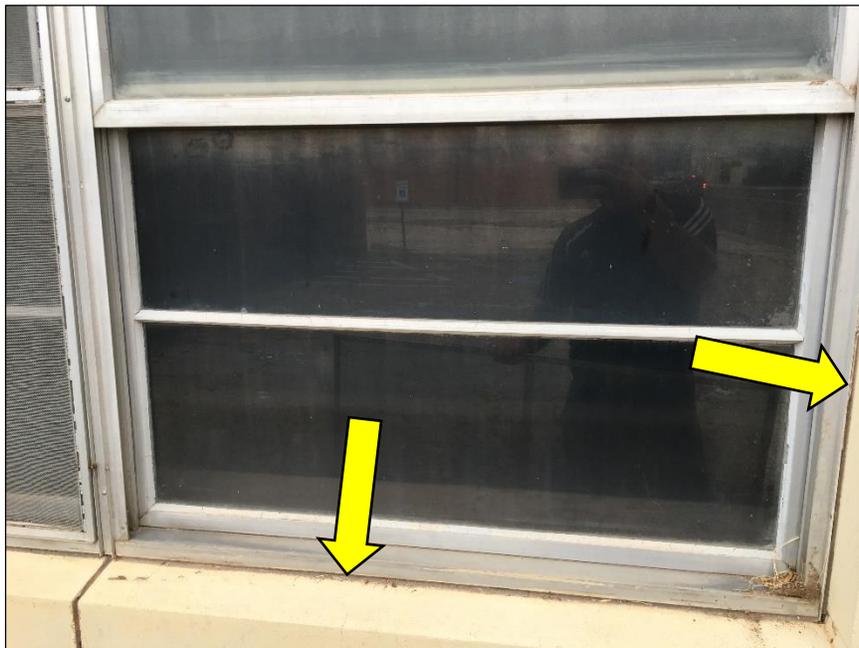
The ACM exterior window caulk was observed to be nonfriable and present in a cumulative quantity below the NESHAP regulatory threshold of 160 square feet, 260 linear feet or 35 cubic feet and is, therefore, exempt from the requirement for abatement prior to renovation operations that would disturb this material. While this material is exempt from regulation under the NESHAP or TAHPR, renovation operations impacting this material are subject to OSHA regulations; therefore, Terracon recommends this material be removed prior to renovation operations impacting the window frames. If the ACM exterior window caulk is left in-place during renovations impacting the window frames, the contractor is not required to be a licensed asbestos abatement contractor; however, the contractor must conduct OSHA asbestos air monitoring and have a trained competent person on site to ensure the materials do not cause airborne fiber counts to exceed the OSHA permissible exposure level of 0.1 f/cc of air.

**Photo 14.** View of exterior window and ACM caulk.
