Request for Qualifications, 17MCO519 DESIGN - BUILD SERVICES

**CRTC Building
215 W. Industrial
Midland, Texas**

February 13, 2014
Terracon Project No. 94147043

Prepared by:
Terracon Consultants, Inc.
Dallas, Texas

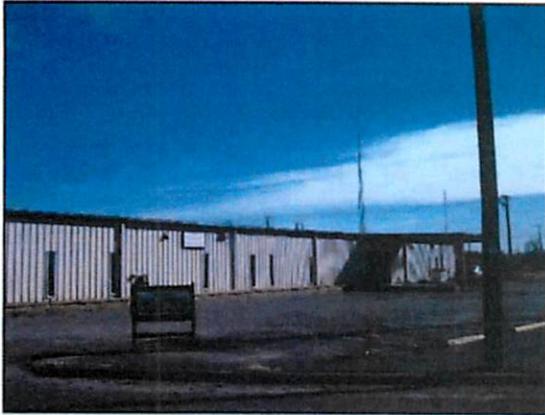
Photo 1 Exterior overview

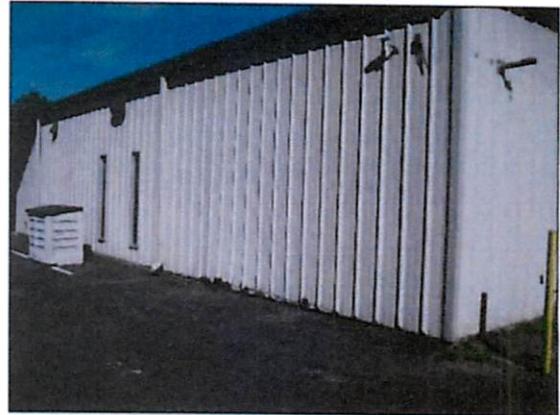
Photo 2 West exterior, south wing, overview

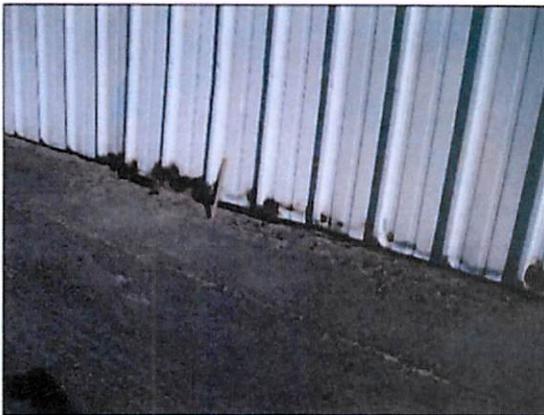
Photo 3 West exterior, rust/deterioration in vicinity of south wing restroom

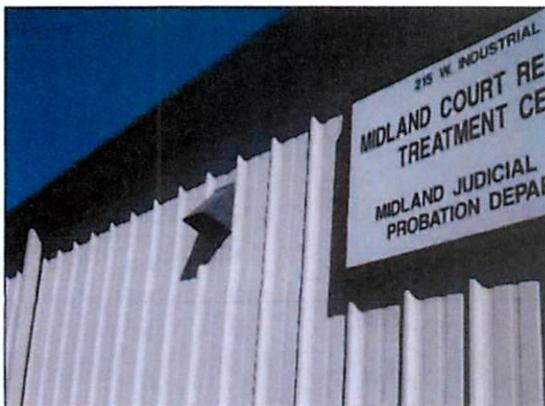
Photo 5 West exterior, north wing, restroom exhaust ventilation

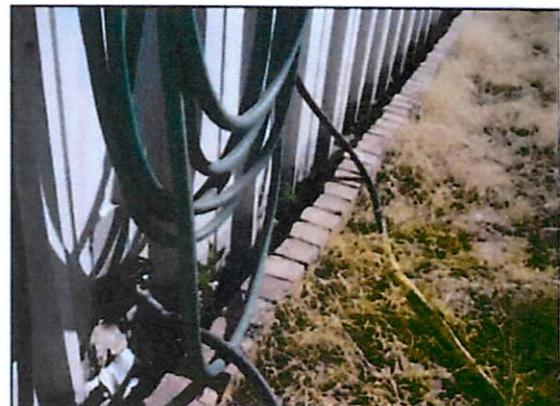
Photo 6 West exterior, north wing, rust/deterioration at faucet head

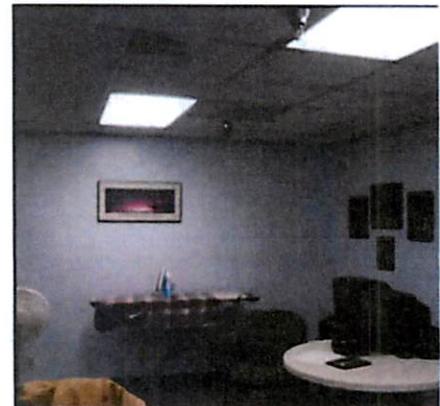
South Wing, SSC Room 10 (Photos 24, 25): Multiple water stained ceiling tiles were observed in the SSC room at the time of the IEQ evaluation. Moisture content of the affected ceiling tiles was normal and there was no visible evidence of fungal growth on the ceiling tiles. The water stained ceiling tiles appeared to be related to historical roof leaks.

Photo 24 SSC Room 10 overview

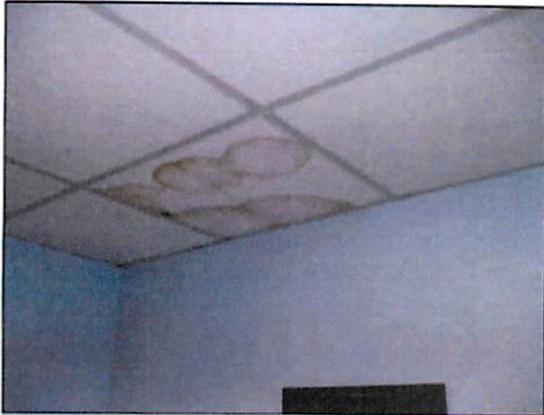
Photo 25 SSC Room 10 water stained ceiling tiles

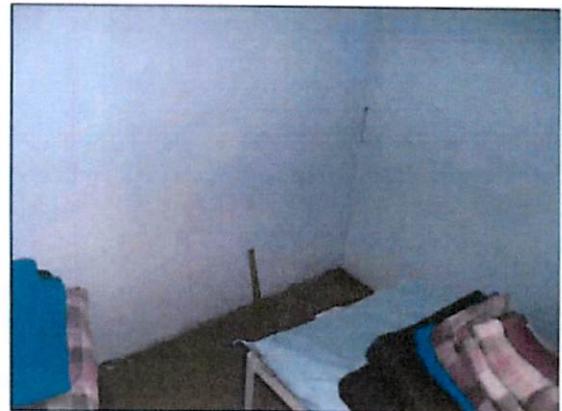
Photo 28 South wing, Room 4, southwest corner common with south wing restroom, evidence of previous wall repair/patch

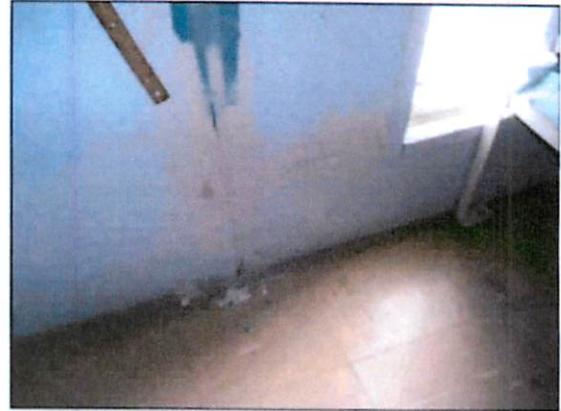
North Wing, Room 4 (Photos 39, 40): Visible evidence of previous wall repair was observed adjacent the window on the exterior west wall (Photos 39, 40). Moisture content of the wall system was normal at the time of the IEQ evaluation as indicated by IR thermography and confirmed with a hand held digital moisture meter.

Photo 40 North wing, Room 4, evidence of previous wall repair/patch on exterior wall system

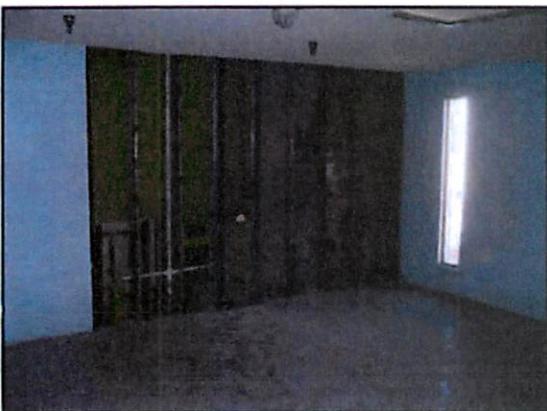
site reconnaissance, a section of the north wall common with the east restroom had been removed from floor to ceiling level, exposing the concrete masonry unit (CMU) shower enclosure and the metal framing (Photo 59). Minor fungal growth was observed on the exposed gypsum wallboard and the metal framing exhibited severe rust/deterioration suggesting long term exposure to moisture (Photos 60, 61). The quantity of visible fungal growth was estimated at two (2) square feet.

Photo 59 North wing Room 3, wall system common with east restroom, previously deconstructed

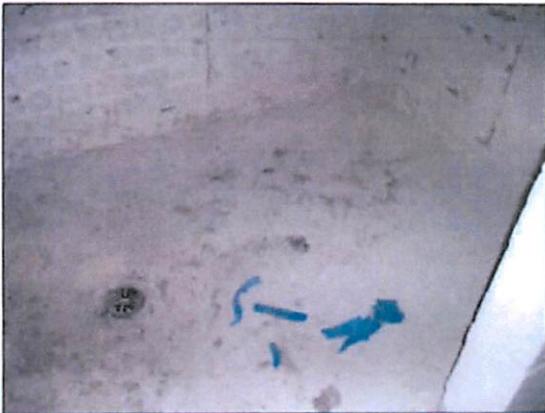
North Wing, East Restroom (Photos 62-66): The ceramic tile on the walls and floor of the shower enclosure had been removed prior to the site reconnaissance (Photo 63). Mr. Davenport previously indicated that during the deconstruction of the shower it was discovered that there was not a shower pan installed in the floor of the shower. Additionally, sections of the gypsum wallboard had been deconstructed exposing water damage and rust/deterioration on the metal framing consistent with long term moisture exposure (Photos 64). Minor fungal growth was observed on the exposed south wall behind floor trim which had previously been removed (Photo 65). The quantity of visible fungal growth behind the floor trim was estimated at less than one (1) square foot.

Photo 63 North wing, east restroom, west wall previously deconstructed

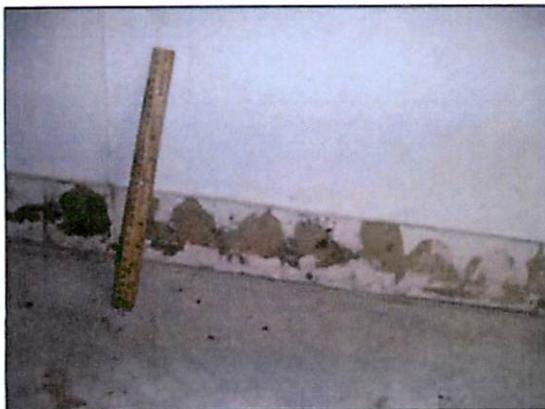
Photo 65 North wing, east restroom, minor fungal growth at floor trim area

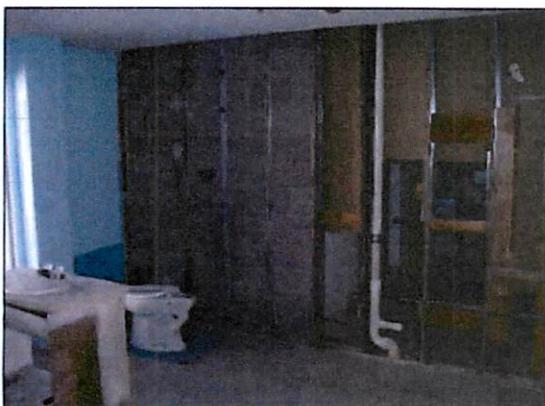
North Wing, Room 5 (Photos 70-73): Room 5 was located adjacent the north wing east restroom. A section of the wall, common with the east restroom, had previously been removed from floor to ceiling level, exposing the CMU shower enclosure and the metal framing (Photo 71). The metal framing exhibited rust/deterioration consistent with long term moisture exposure (Photo 72). Apparent rust stains were also observed on the floor tile adjacent the window, suggesting historical moisture migration through the east exterior wall system or from the adjacent shower enclosure (Photos 73).

Photo 71 North wing, Room 5, wall common with east restroom, wall system previously deconstructed

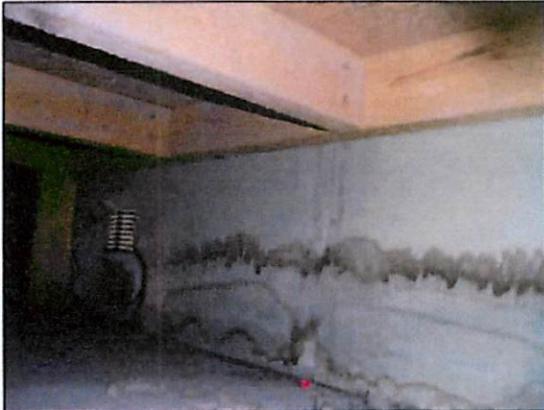
South Wing, North Wing, Administration Wing (Photos 74-83): The interior of the return air plenums of the AHU's servicing the south and north wings were accessible for visual evaluation. The interior of the south and north wing return air plenums exhibited evidence of previous exposure to moisture or condensate drain pan overflow and suspect fungal growth (Photos 75, 76, 78, 79). The exterior of the return air plenum in the Administration wing exhibited damage and stains that appeared to be associated with moisture or a condensate

Photo 75 South wing, vertical AHU return air plenum, evidence of water staining, suspect fungal growth

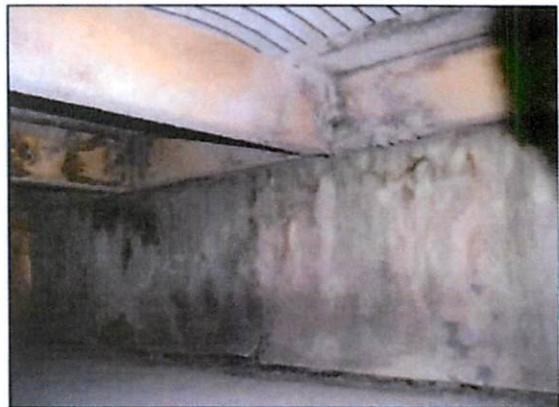
Photo 78 North wing vertical AHU, return air plenum, evidence of water staining, suspect fungal growth

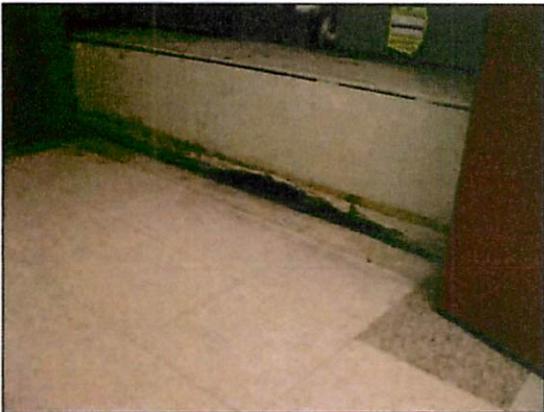
pan overflow (Photo 81). The surfaces within the referenced return air plenums were not accessible for sample collection. The quantity of suspect fungal growth in both the south and north wing return air plenums was estimated at less than one (1) square foot.

Photo 81 Administration wing, vertical AHU platform, evidence of water damage
